IIT RESEARCH INSTITUTE
Technology Center
Chicago, Illinois

SHELTER HABITABILITY IN EXISTING BUILDINGS
UNDER FIRE EXPOSURE

Thomas E. Waterman

June, 1966

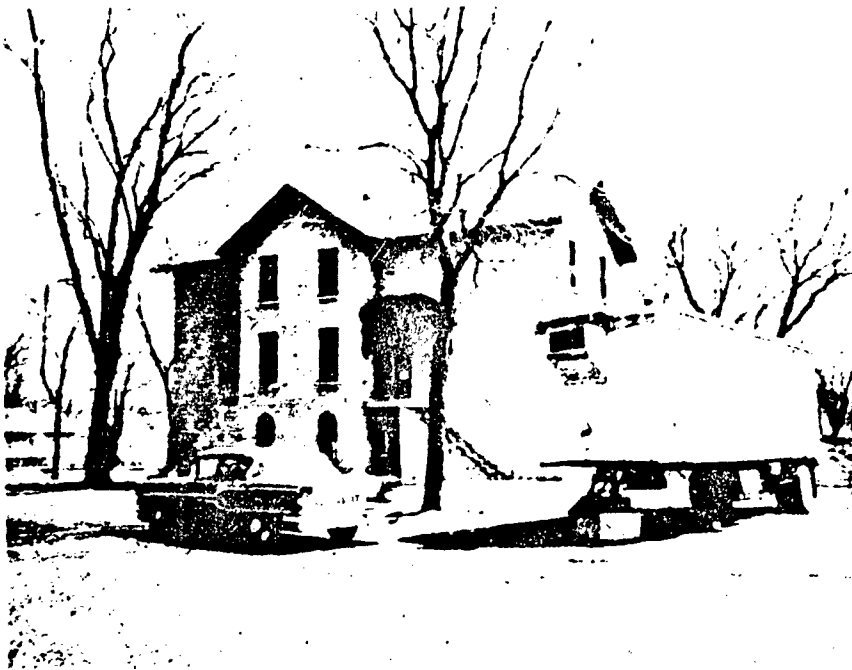
Figure 1. Building No. 1 (Waukesha, Wisconsin)

Photographs of the building are shown in Figure 1 and a schematic cross-section of the building is shown in Figure 2. Two experiments were conducted in this building. In each, the fire was started in the first floor room labeled "fire origin" in Figure 2. This room and a portion of the adjacent one were lined with gypsum board and sheet metal to extend the period during which the fires resembled those which would occur in a fire resistive structure. Doors within the structure were arranged so that smoke and hot gases were channeled across the first floor and upward through a stairwell to the third floor level. A drop partition was placed in the middle first floor room to restrict the gases to a twelve-foot wide segment and this portion of the room received additional ceiling protective covering. Cross-hatching in Figure 2 indicates the portion of the building acting as a barrier to the smoke and gas spread. External openings were protected with sheet metal curtains extending downward to within several inches of the sills. In the first experiment all doors and windows (except

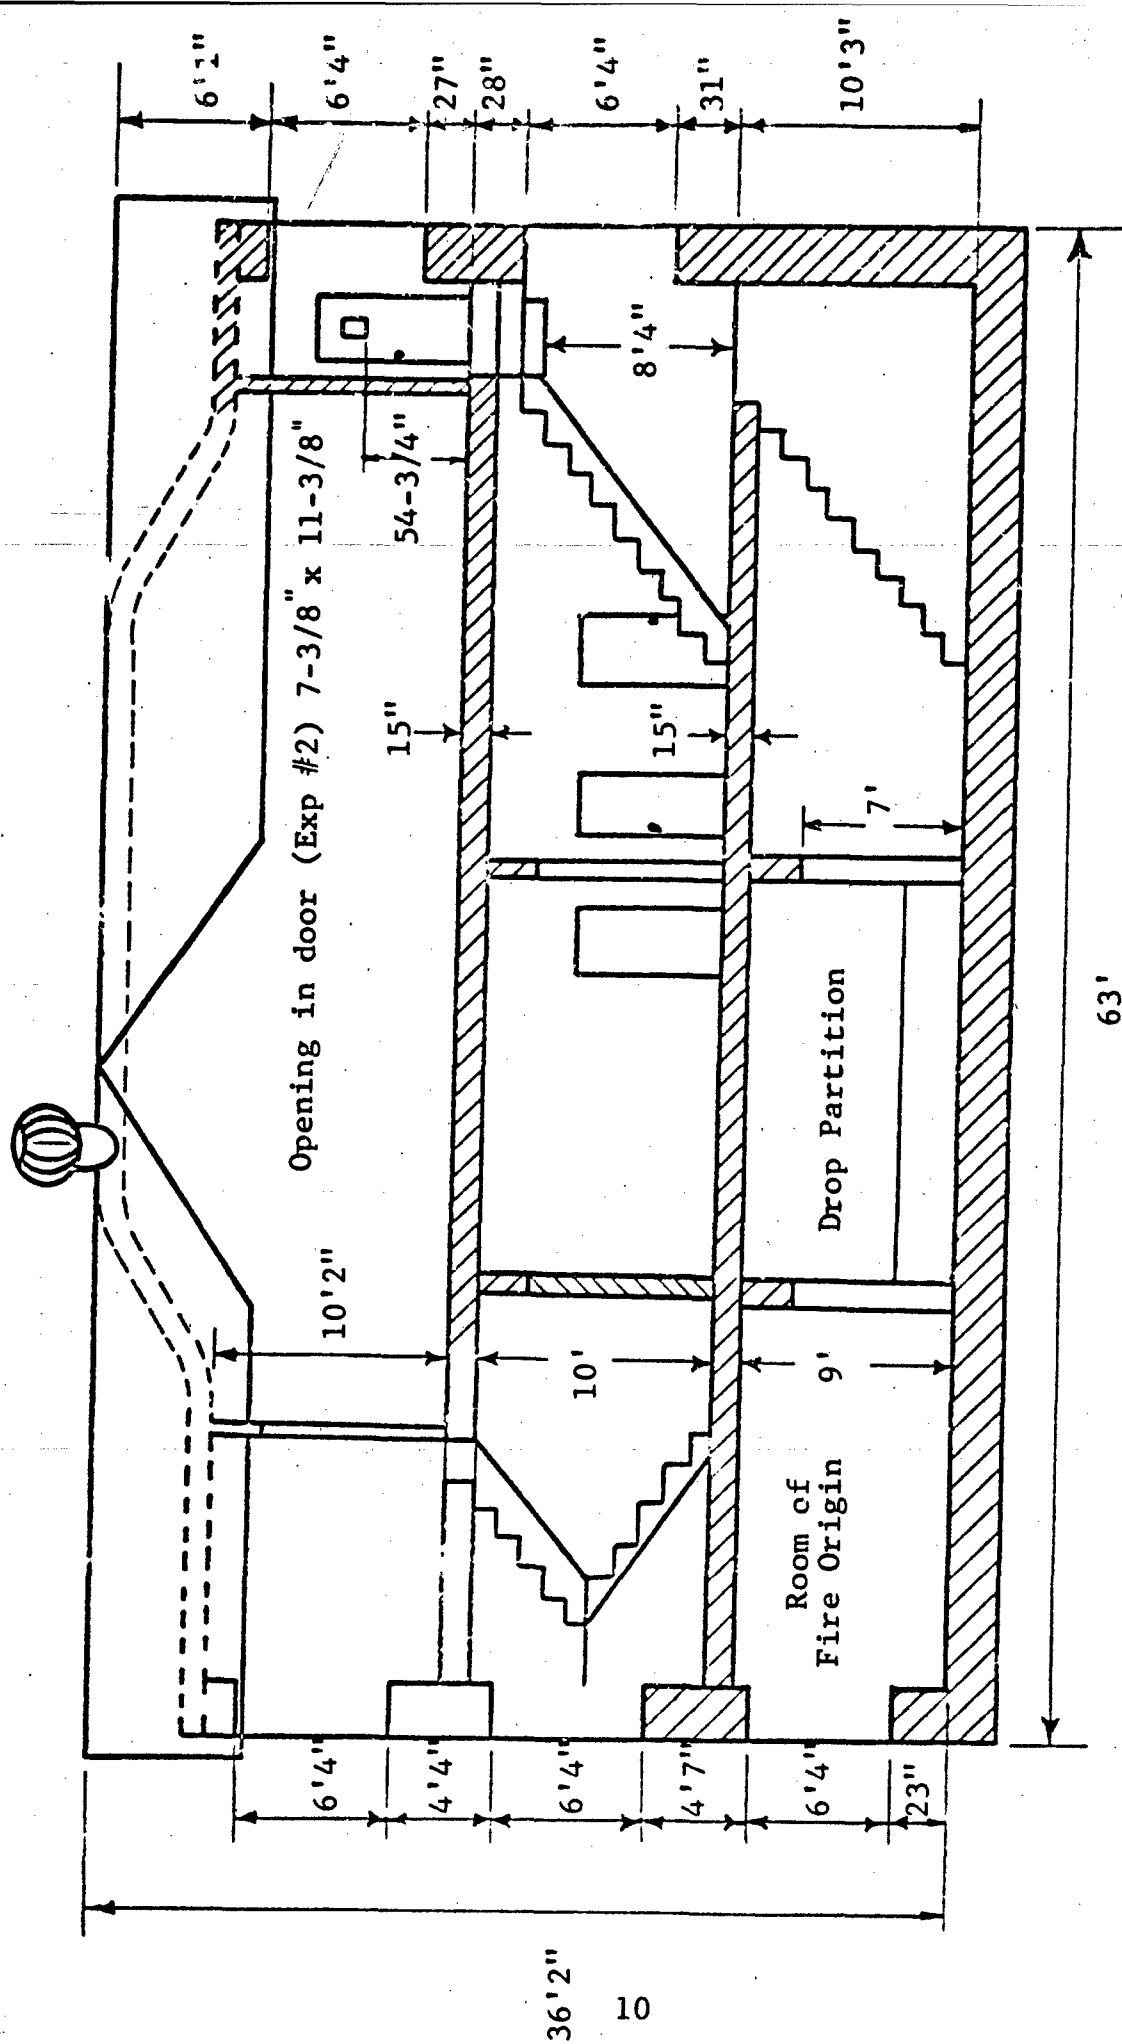
Figure 2. Schematic Cross Section of Building No. 1 (Waukesha, Wisconsin)

in the room of origin) were tightly closed. In the second experiment, a small opening was made in the door at the third floor to permit some bulk gas flow up the stairwell. These experiments can be considered similar to those conducted in "Operation School Burning"⁽³⁾ except that here a deliberate attempt was made to minimize the volume available for dilution of the fire gases and to maximize the pressure buildup in the stairwell.

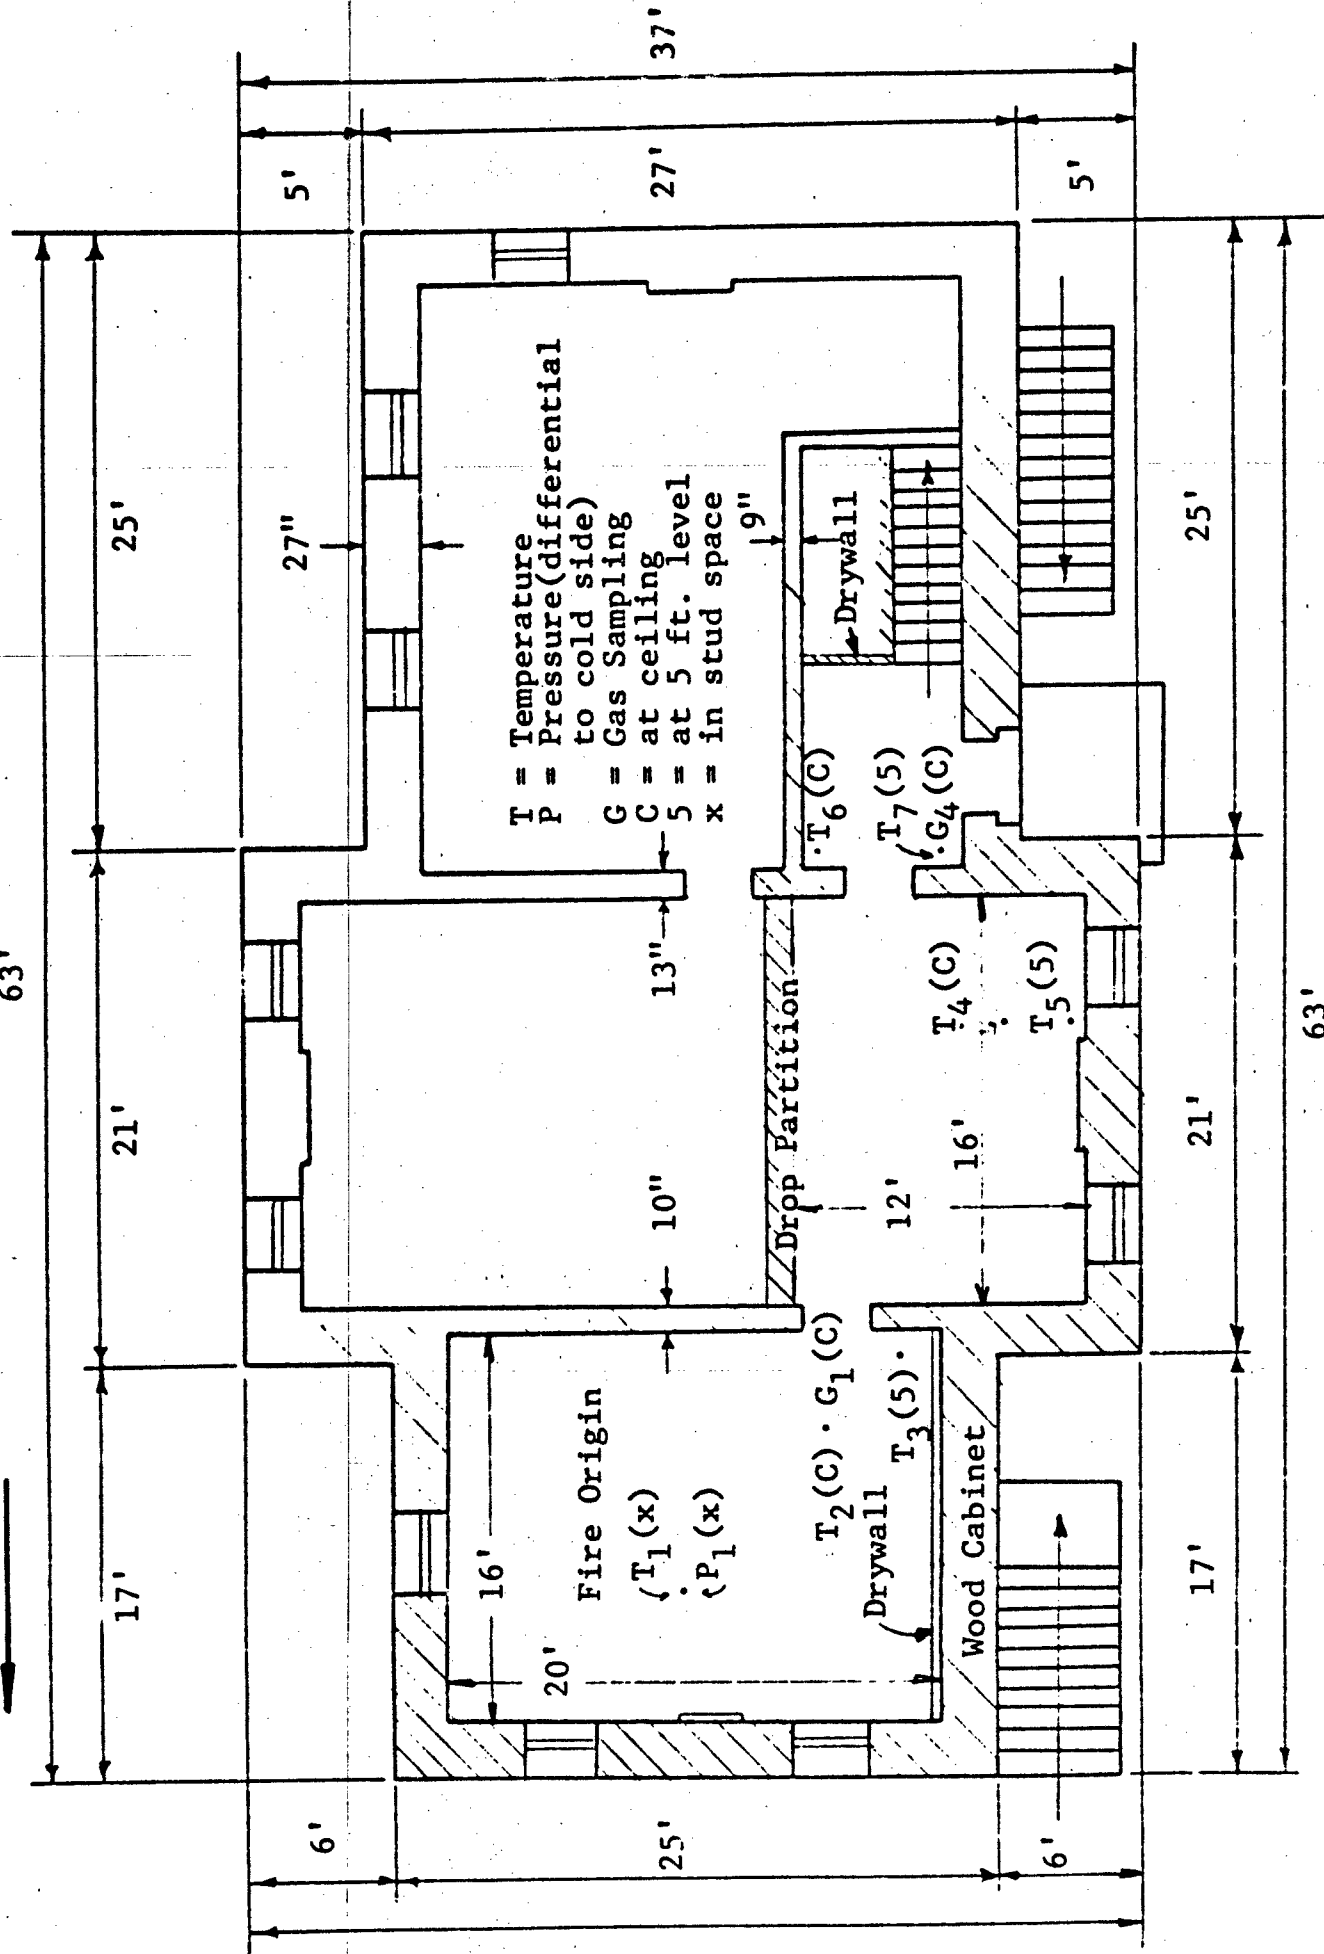
Temperatures, pressures and CO and O₂ concentrations were monitored at various points along the path of the fire gases as shown in Figure 3. Gas flow was measured at the third floor door opening in Experiment No. 2. Weight losses of fuels in the room of origin were recorded as well as radiant heat fluxes from the openings.

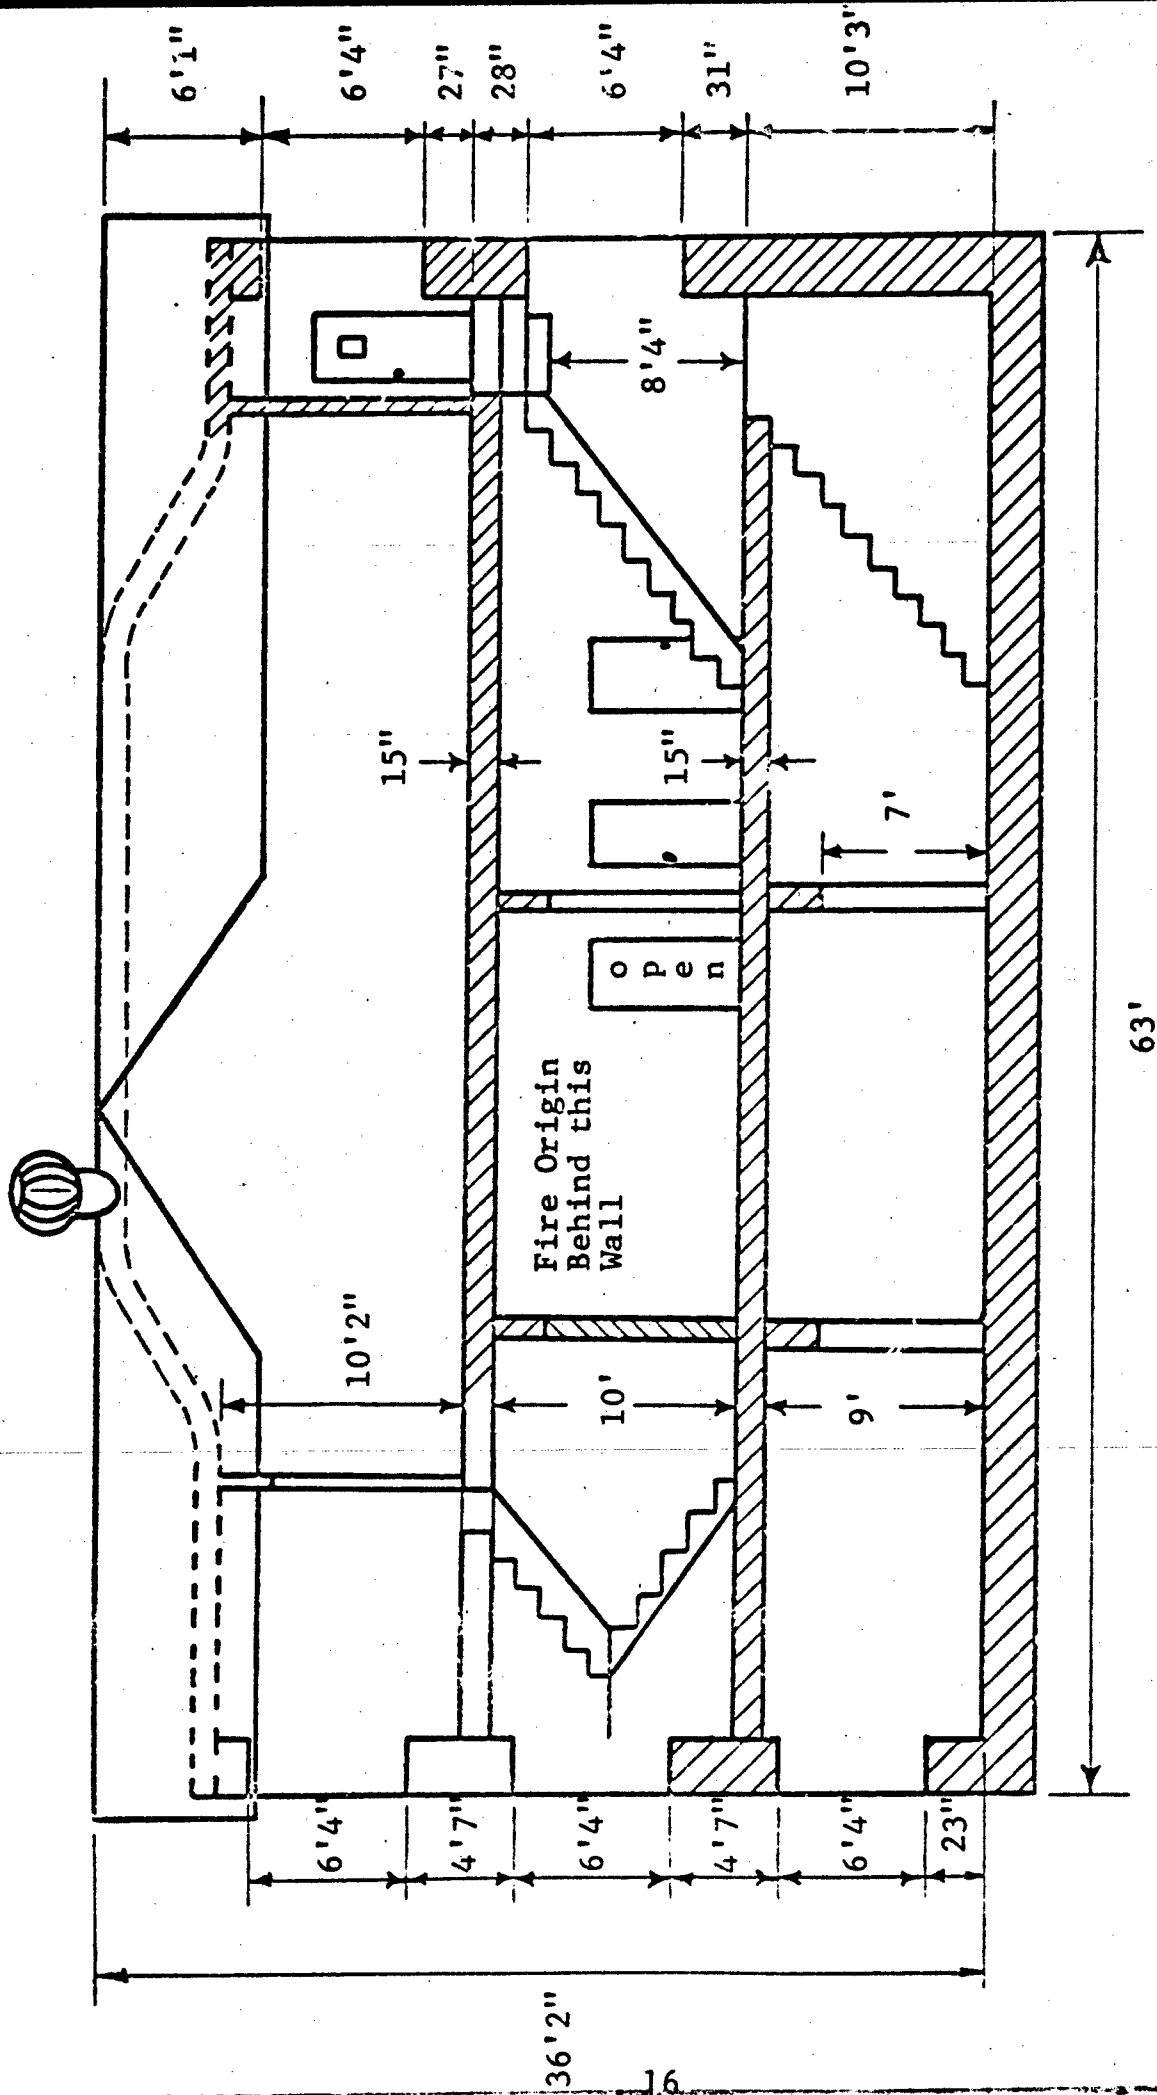
Figure 4. Schematic Cross Section of Building No. 2 (Waukesha, Wisconsin)

building is shown in Figure 4. Cross hatching has been added to Figure 4 to indicate the portions of the building acting as a barrier to smoke and gas spread. One experiment was conducted in this building. The room of fire origin was on the second floor. Although it was not located above the first floor room used in Building No. 1, the path for smoke and gas spread and the volumes available along the path were quite similar. Again, the room of origin and a portion of the adjacent one were lined with gypsum board and sheet metal. Also, windows and doors were tightly closed (except in the room of origin) and protected where necessary.

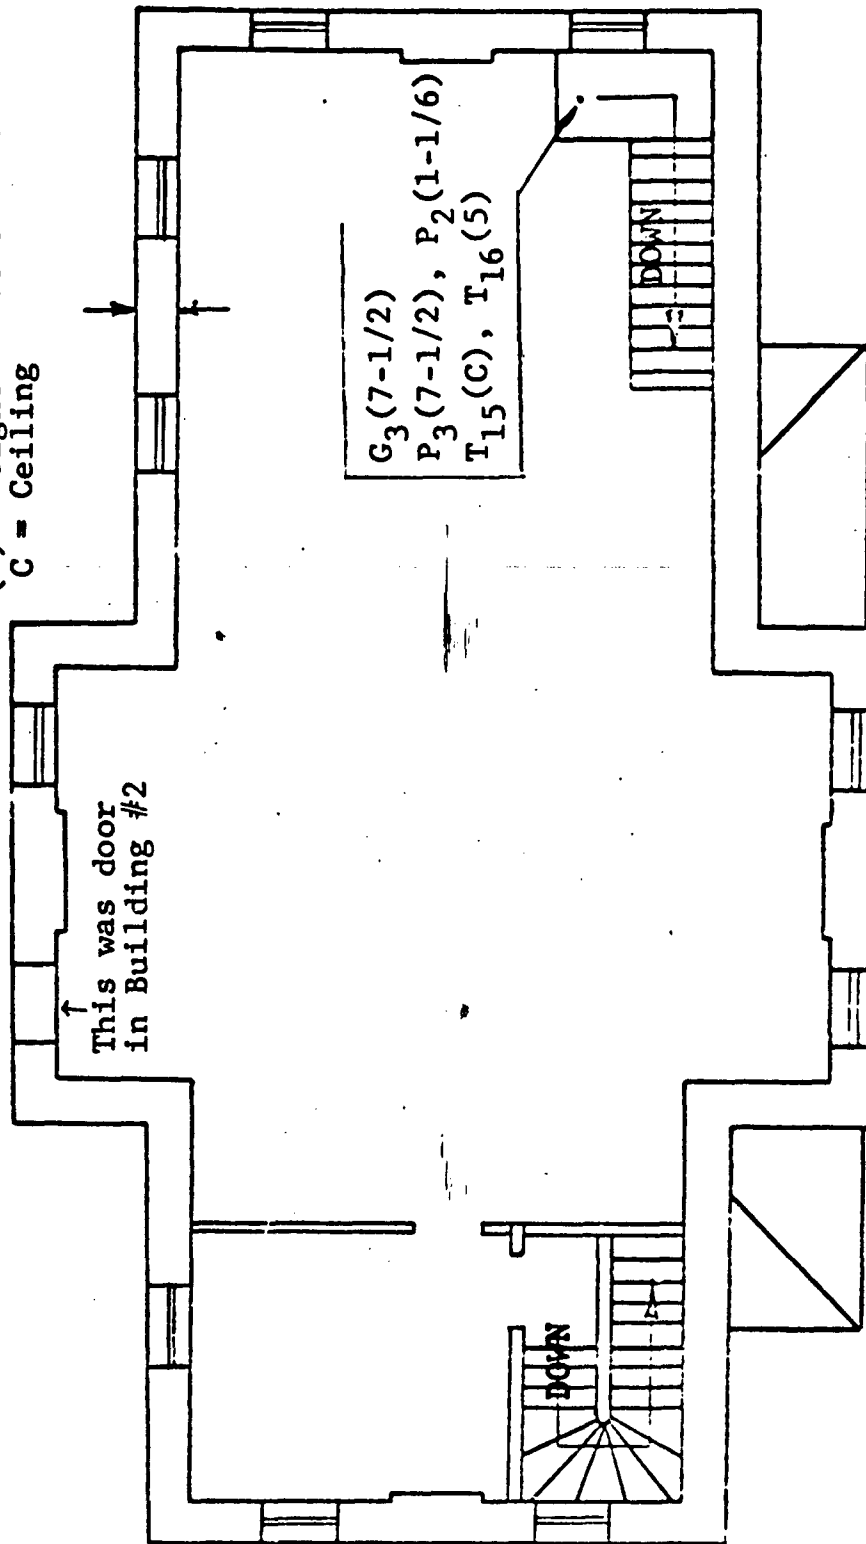
Figure 5C. Third Floor, Building No. 2 (Waukesha, Wisconsin)

G = Gas
 P = Pressure differential across door
 T = Temperature
 () = Height above 3rd floor-floor level
 C = Ceiling

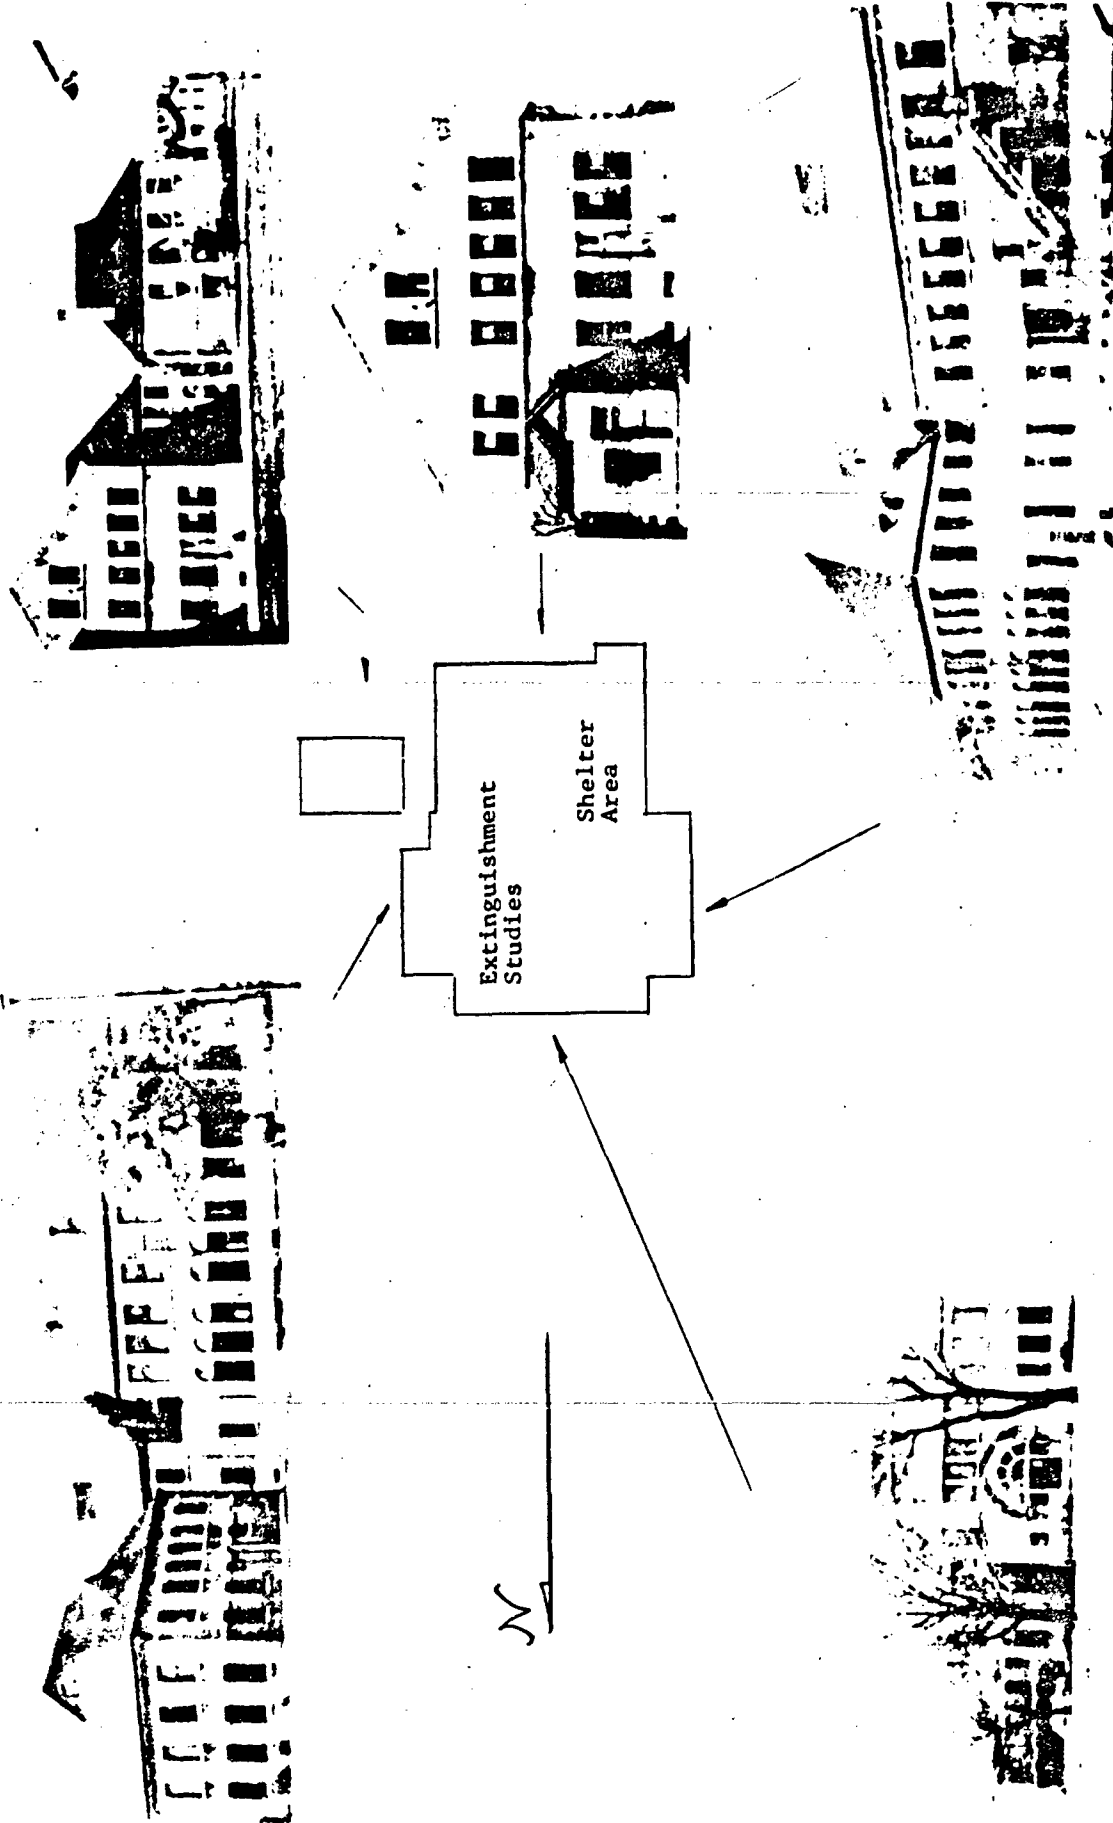
Figure 6. Photographs of Building No. 3

drawing in Figure 6. The auxiliary structure shown in Figure 6 was a laundry building which ignited by radiation from Building No. 3 during the peak of the burn. This ignition was suppressed and burnout of the laundry did not occur.

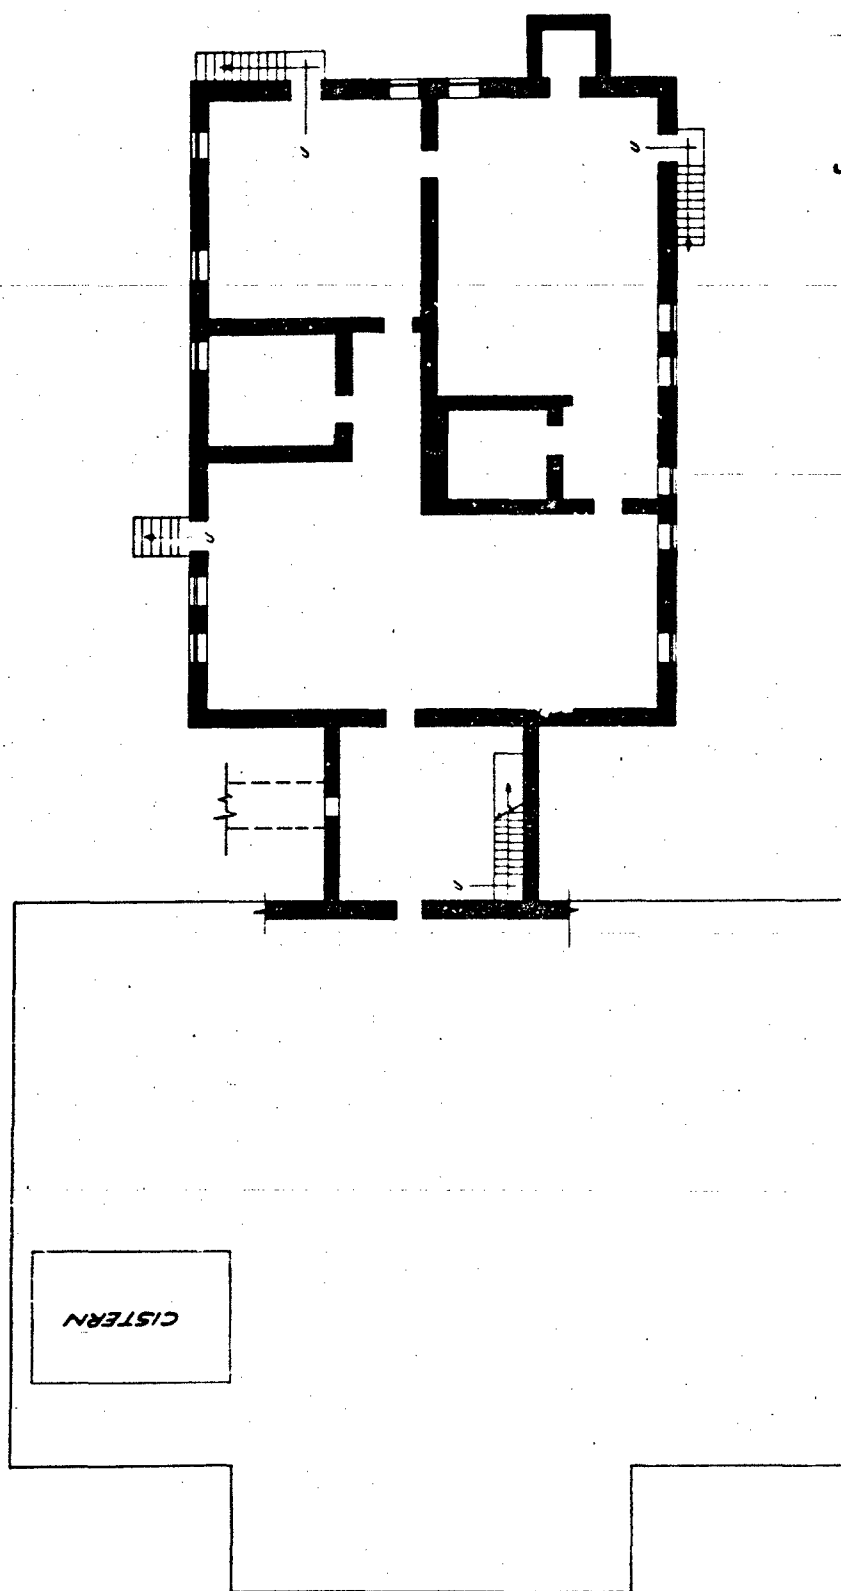
Building No. 3 contained a dining hall (first floor) and auditorium (second floor) in the older portion (north) and had a large kitchen with cold storage vaults (first floor), music rooms and classrooms (second floor) in the newer portion (south). Ceilings and walls in the first and second stories were plastered. In addition, acoustical tile had been placed over the ceiling in the dining hall. Acoustical tile also had been added to the walls and ceilings of a series of small rooms built into the south end of the second story. Figure 7 shows the floor plans for the basement and each story. It might be noted that in addition to some interior brick load bearing walls, cast iron columns were used in the dining hall to support steel beams carrying the load of the second floor auditorium. The auditorium ceiling contained beams which were incorporated into a truss arrangement in the attic as shown in Figure 8. Because of the large room area and volume afforded by the dining hall (60 x 90 x 18 feet high) it was used to examine the minimum water requirement for extinguishment of this size room fire. Upon completion of the extinguishment experiments, the fire was allowed to rekindle and spread throughout the structure.

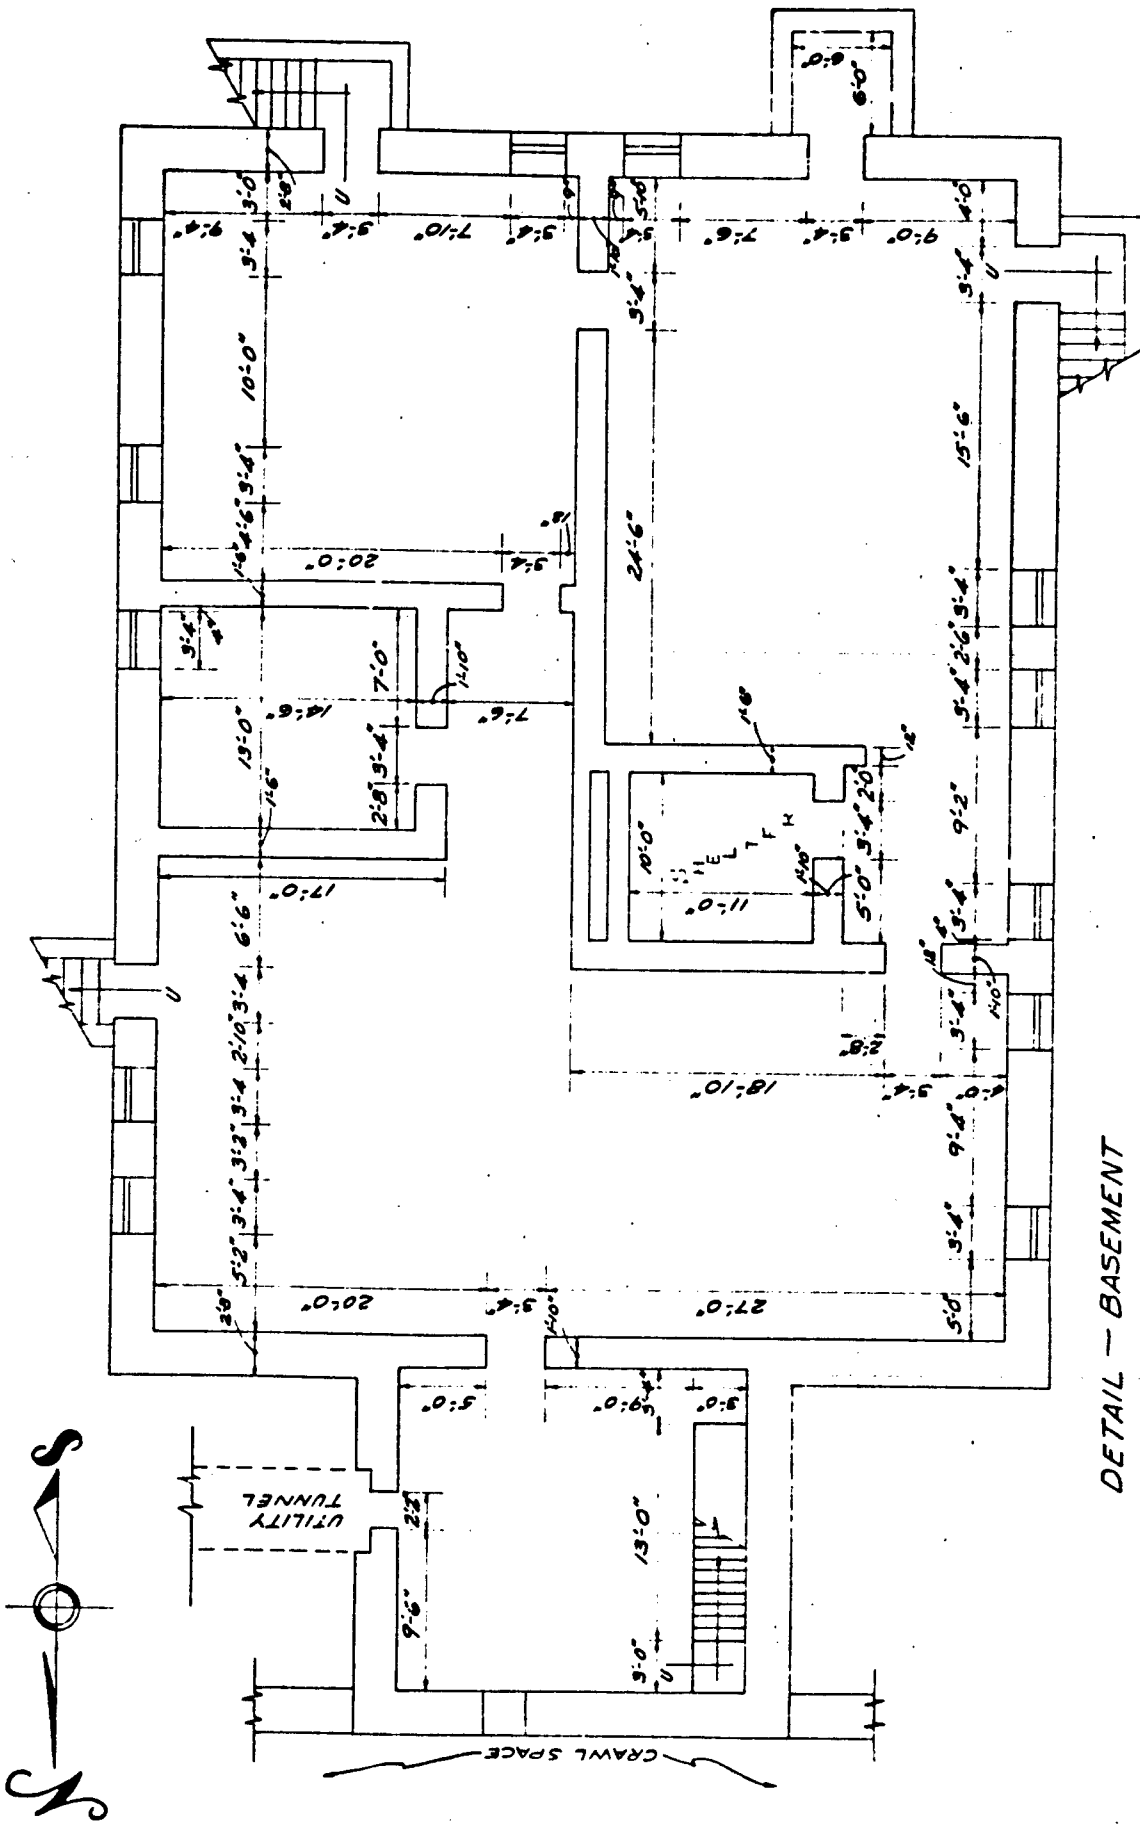
Figure 9. Detail of Easement Area, Building No. 3

considered fire resistive. Conditions in and around this fire resistive basement area were monitored during the structural burnout. Details of the basement are included as Figure 9. The interior room labeled "shelter" was analyzed by M. P. Gronbeck, a qualified shelter analyst. Excerpts from his report follow:

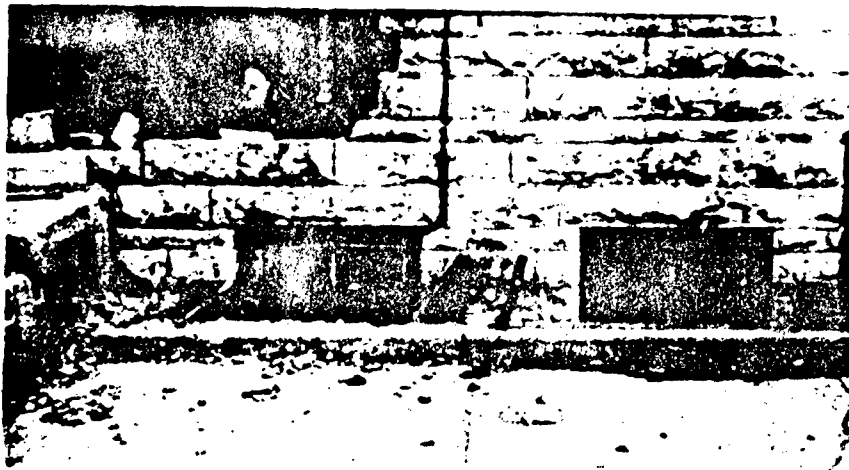
Figure 10. Windows in Basement Area Near Shelter Building No. 3, Waukesha, Wisconsin

Note - Basement windows were covered with sheet metal or plaster board to simulate a condition in which windows are bricked-over. The coverings remained intact throughout structural burnout.

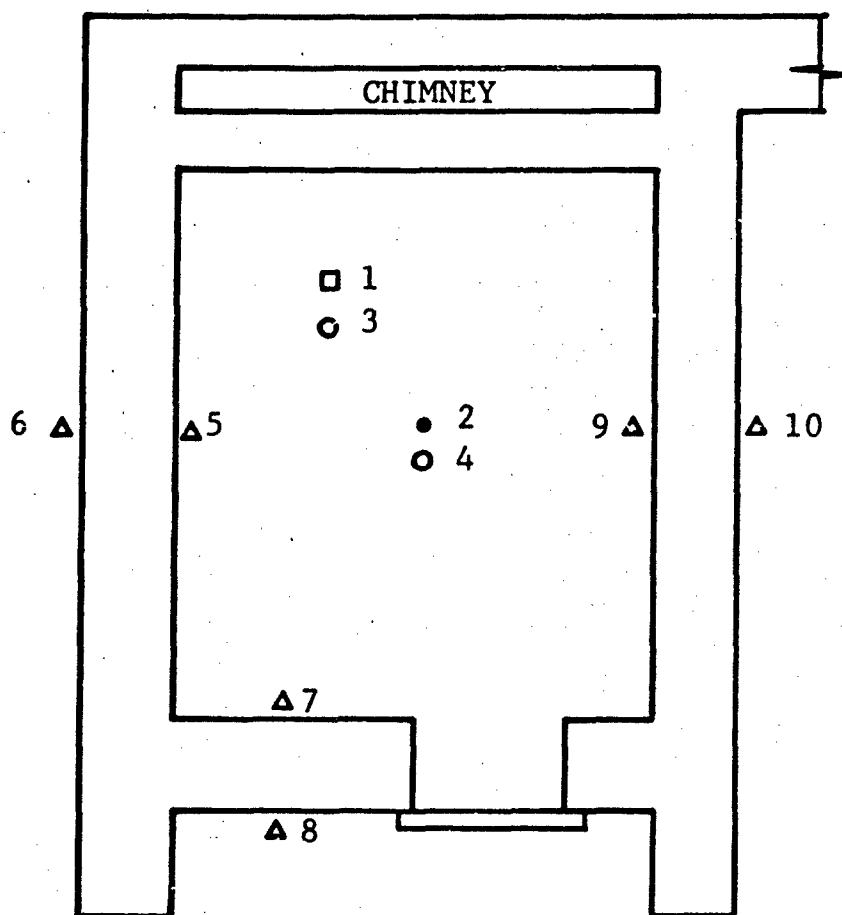
Figure 11. Temperature Measurement in or near
 Shelter Area - Building #3 (Waukesha, Wisconsin)

Code: Δ = 5 ft. level
 • = 2" below ceiling
 \square = attached to ceiling
 \circ = 2" above first floor

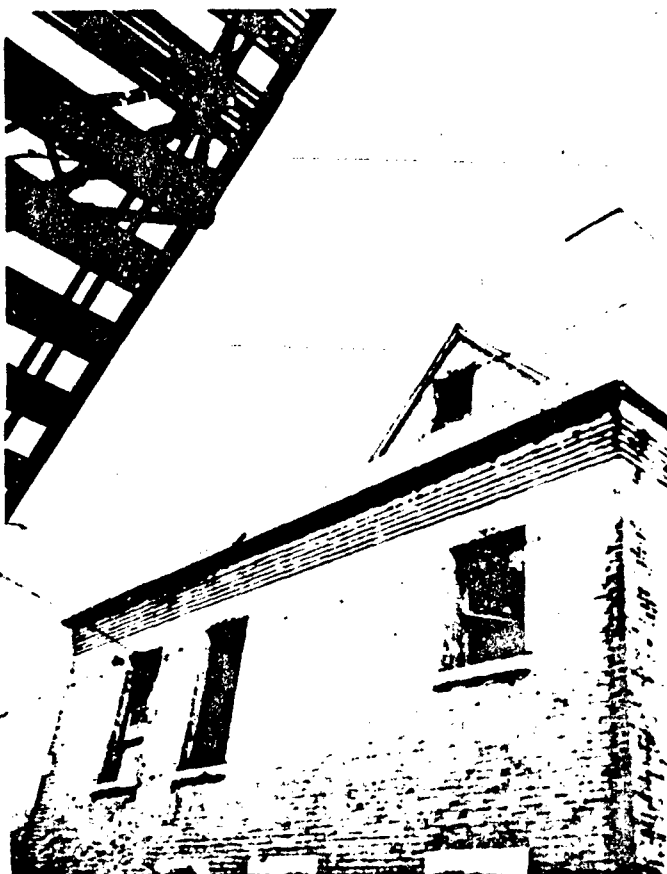
Figure 13. Radiometers, Burn 3 (Waukesha, Wisconsin)

Radiometer #3
facing west

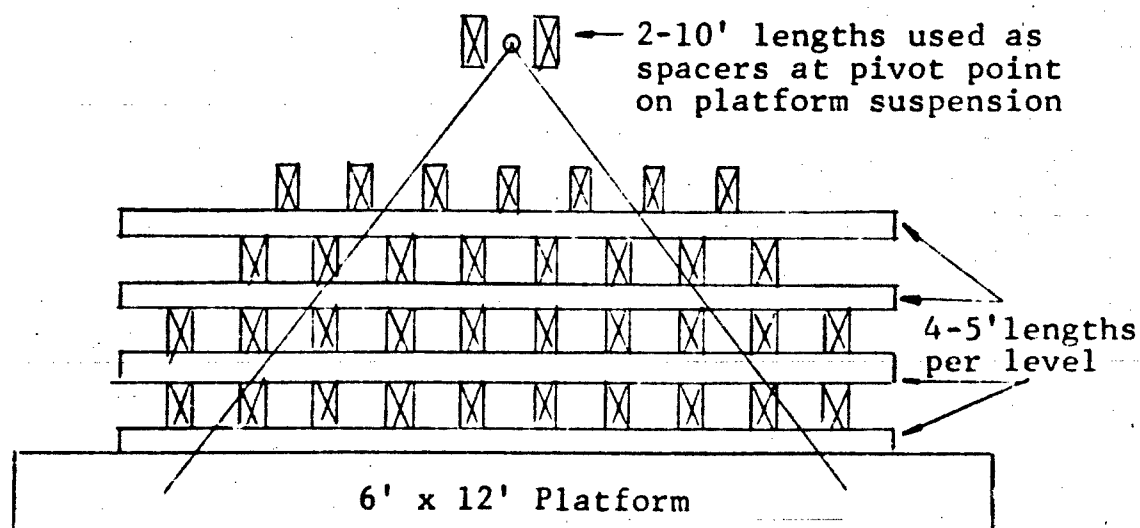
Figure 14. Crib Arrangement for Buildings 1 and 2

The cribs used in Buildings 1 and 2 consisted of 2" x 4" lumber placed on a weighing platform (described in Appendix A). Each crib consisted of 450 lineal feet (or 600 pounds) of lumber placed in alternating rows of 10 ft. lengths on edge and 5 ft. lengths laid flat as shown below.

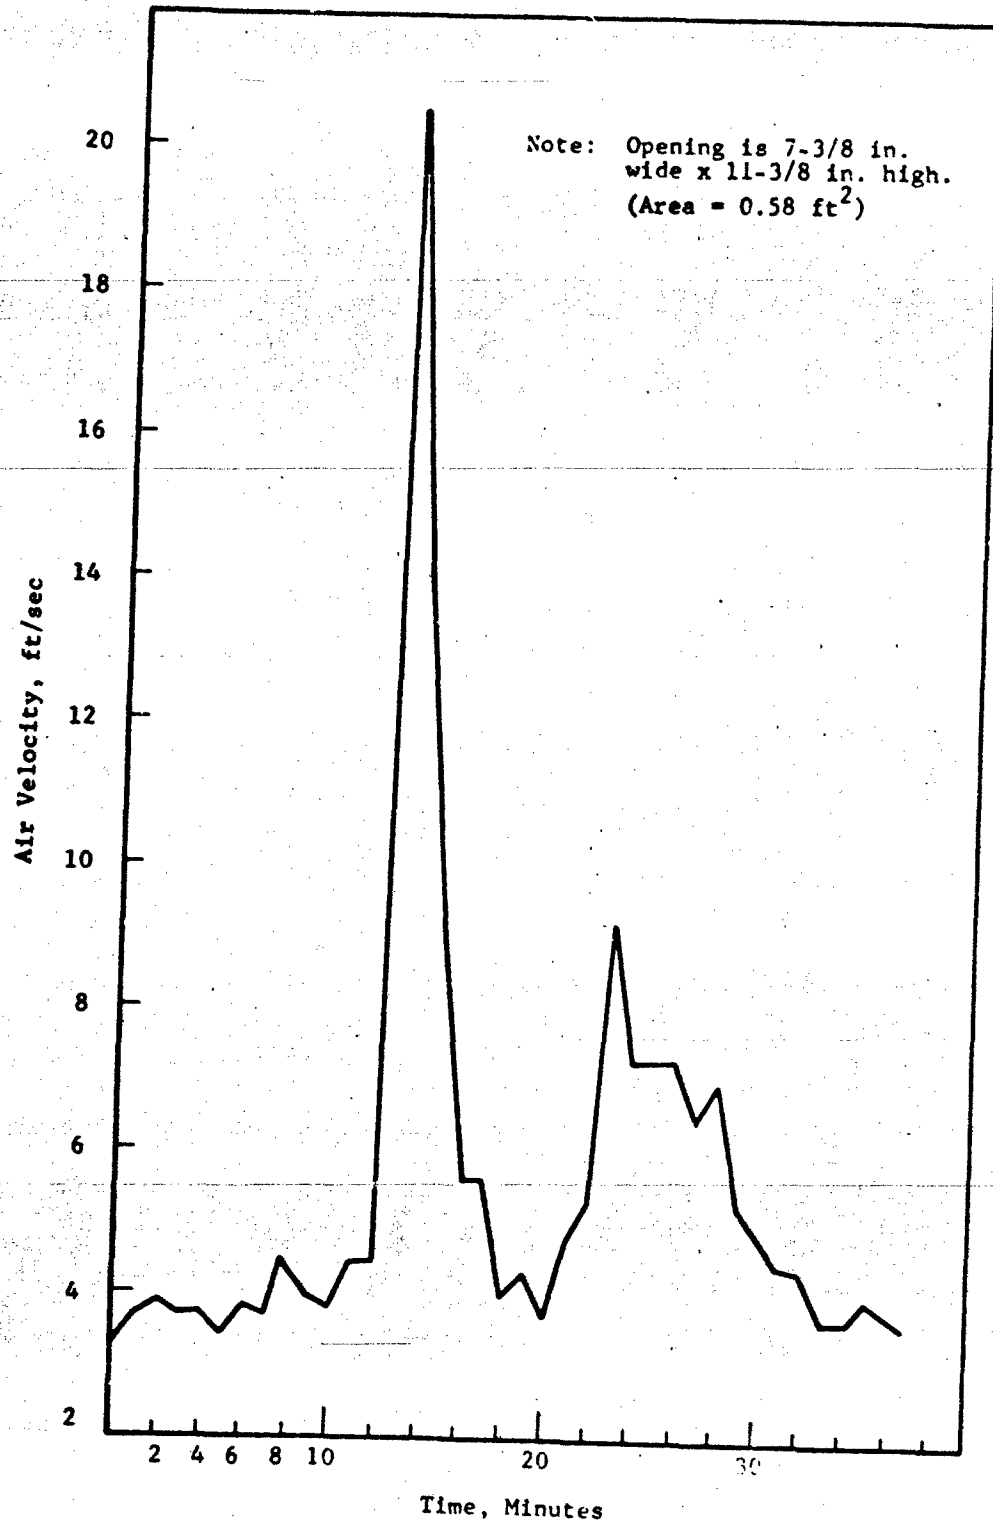
Figure 17. Air Flow from Stairwell Vent Experiment 2, Building 1

was such that the air flow tended to be through the crib thus overcoming, to a significant degree, the natural restriction of the crib matrix to self-induced air flow and the high burning rate was achieved until the fuel supply decreased.

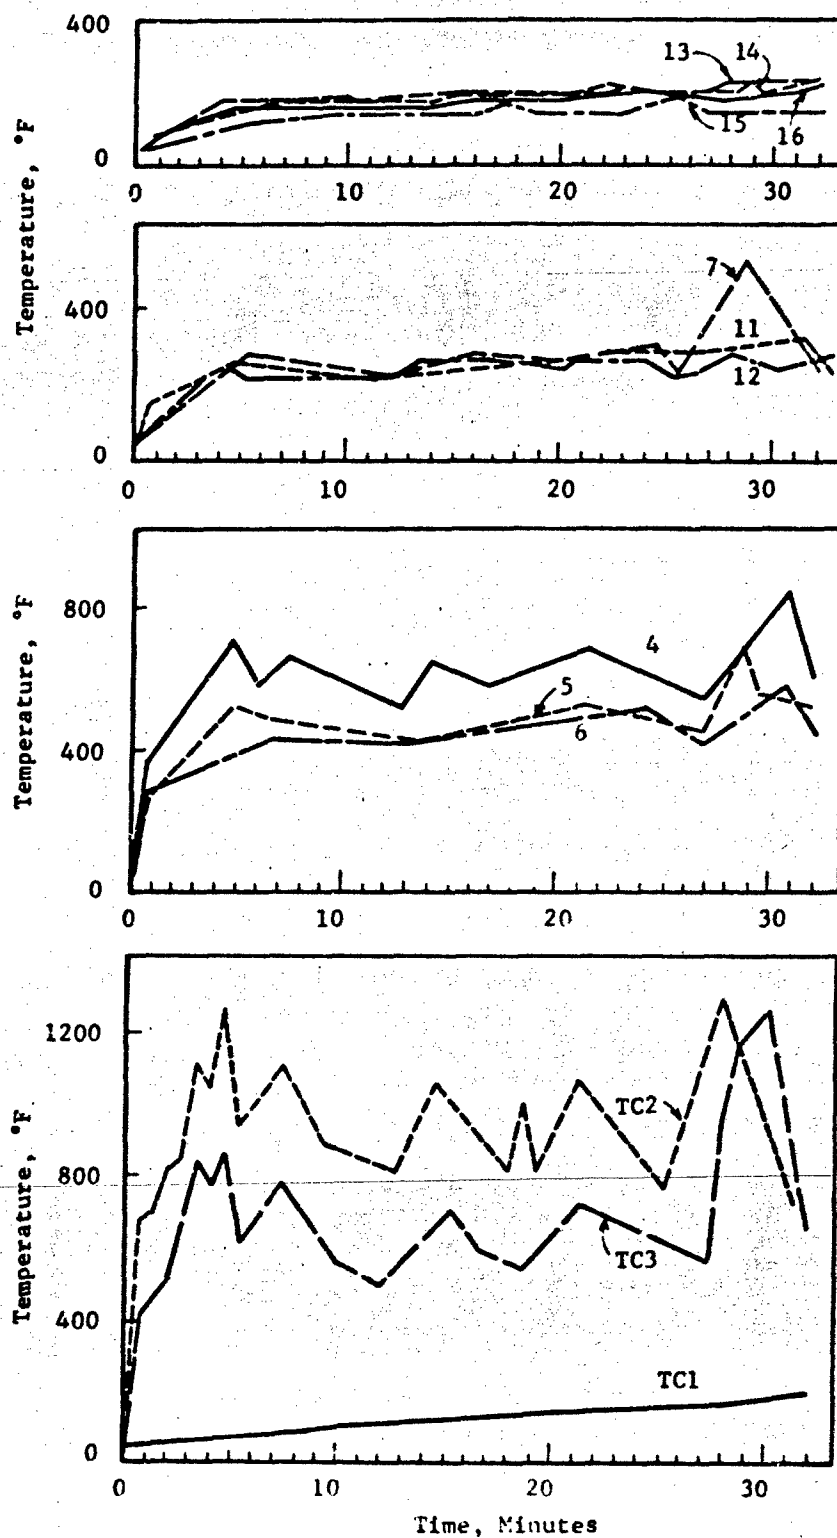
Figure 20. Temperatures, Building No. 1, Experiment No.

A number of observations can be made from the data shown in Figures 20, 21 and 22. First, the fires did last long enough to permit all monitored points to reach an essentially steady-state condition. For example, Figure 20 shows that temperatures at points furthest from the fire (13, 14, 15 and 16) were essentially constant shortly after the peak temperature

was reached in the burn room. The temperature variations of the burn room, although damped with distance, can be seen to appear throughout the path with very little time lag.
